ROYAL AIR FORCE
PROCEEDINGS OF A BOARD OF INQUIRY
INTO AN AIRCRAFT ACCIDENT

1. The Board of Inquiry was assembled on 21 November 2007 at 1030Z at Joint Helicopter Command Headquarters (JHC HQ) by order of Commander JHC to inquire into an accident involving Puma HC1 ZA938 that occurred at approximately 1450Z on 20 November 2007 while on operation in Iraq. A complete diary of the Board's activities, from convening until submission of this report, is at Annex A.

PART 1.2 - CONCLUSIONS OF THE BOARD

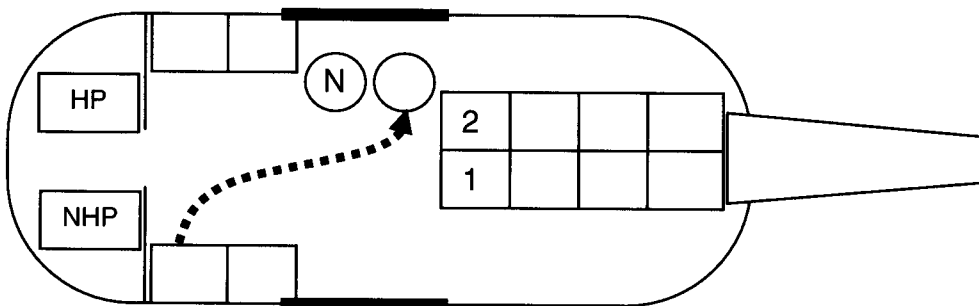
26. Cabin Egress. The details of who was where in the cabin post the final impact is not clear as the many witness statements taken do not agree and therefore make it impossible to locate individuals clearly at any point in time. The diagram below indicates the seating positions immediately prior to the final impact and rollover:
